## CERTAIN 2021 - 2026 MODEL YEAR BRONCO NON-RAPTOR VARIANTS — ENGINE COMPARTMENT WIRE HARNESS REPAIR

### SERVICE PROCEDURE

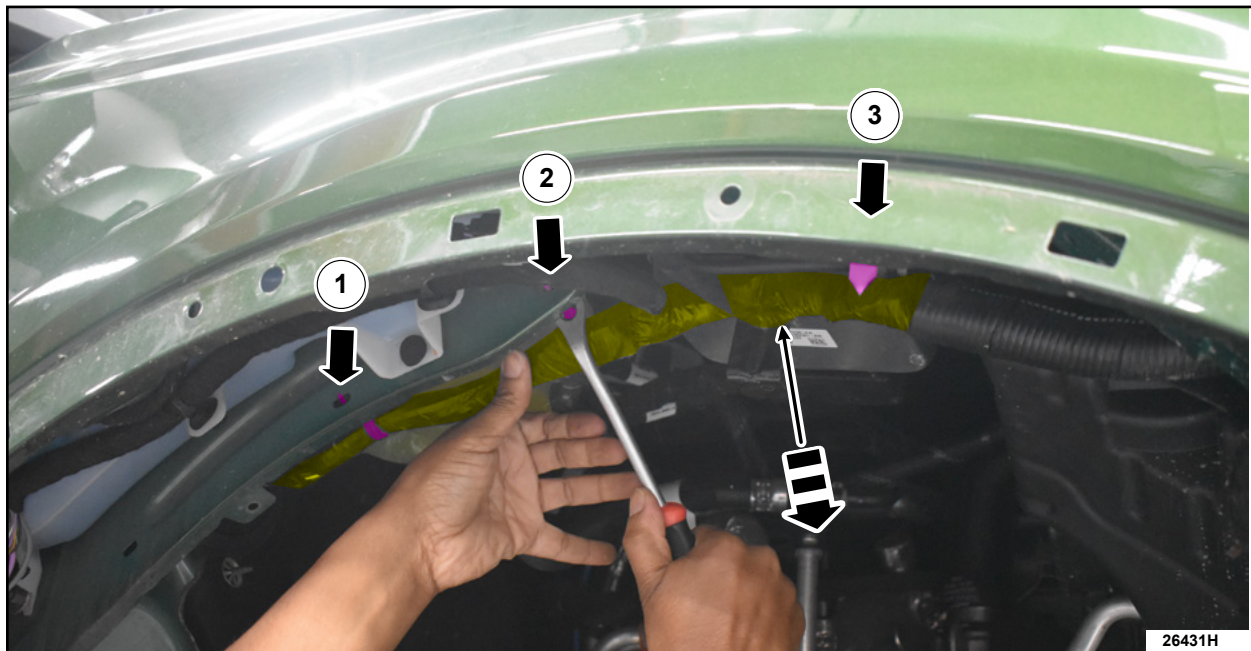
**FIGURE 8**

16. Starting behind retainer (1) and ending after retainer (3). Inspect the harness for broken wires or signs of chafing. See Figure 8.

15. Remove the 3 retainers to reposition the harness into view. See Figure 8.

- (1) retainer
- (2) retainer
- (3) retainer

- Yes - If a wire is broken or chafing is present, repair the wire(s). Follow the Professional Technician System (PTS) [www.fordtechservice.dealerconnection.com/](http://www.fordtechservice.dealerconnection.com/) procedures under Wiring Tab>005 Connector Repair Procedures.  
Once completed, proceed to Step 19.
- No - Proceed to Step 19.

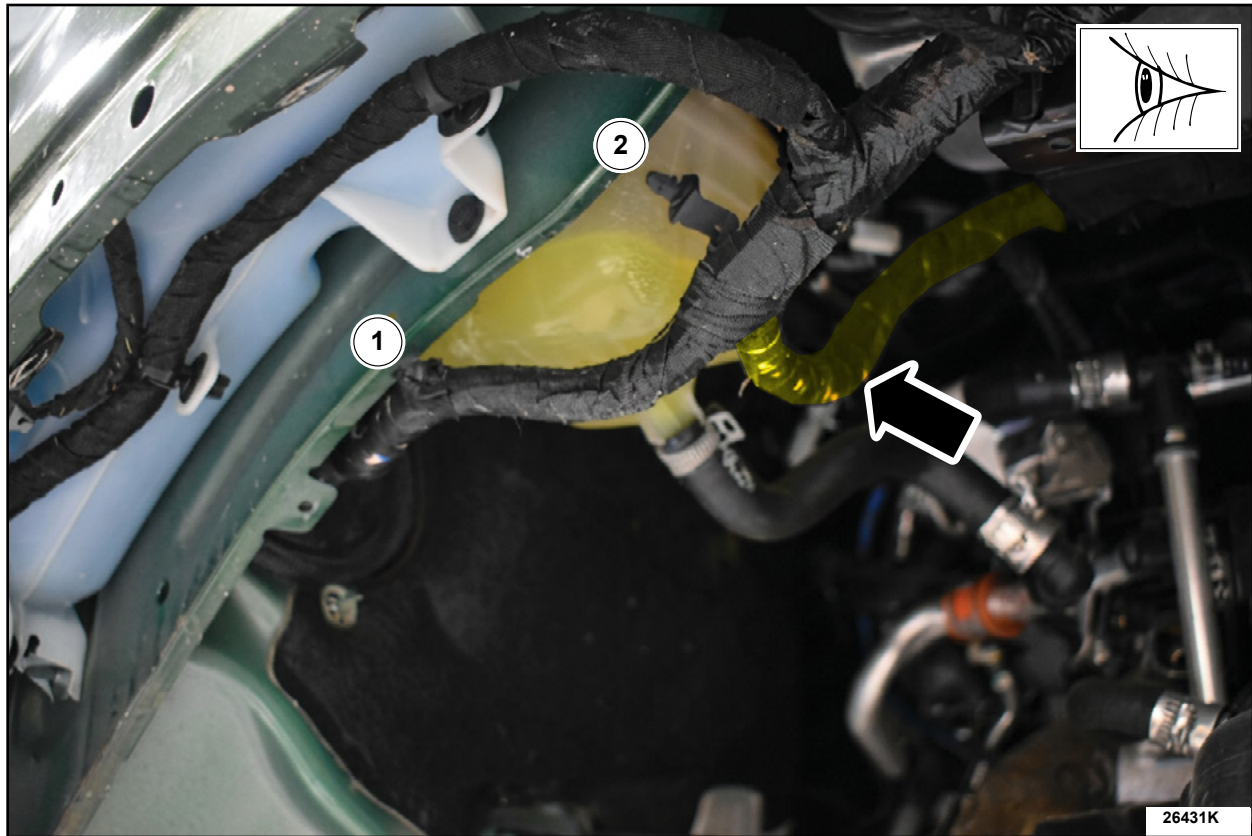
**FIGURE 9**

17. Starting at retainer (2), inspect the portion of the harness that goes up past the degas bottle.  
See Figure 9.

- (1) retainer  
(2) retainer
