## TECHNICAL SERVICE BULLETIN

### Soft Top Roof - Loose Exterior Fabric On Rear Window

**22-2055**  
21 February 2022

<b>Ford</b> 2021-2022 Bronco	Soft top roof
---------------------------------	---------------

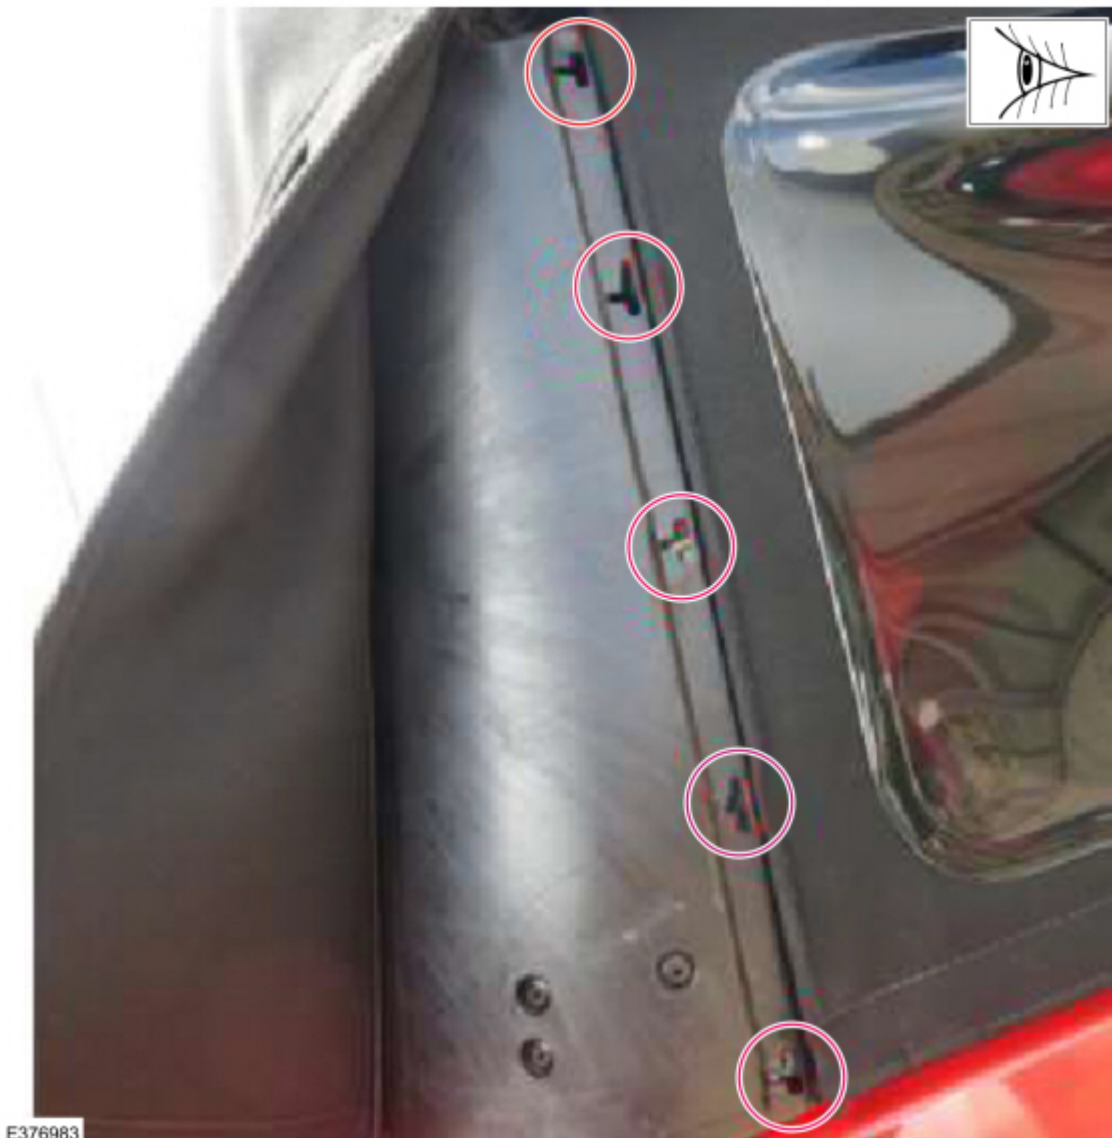
Figure 1 - Right D-pillar shown, left side similar

1. Visually inspect the 5 clips that run vertically along each D-pillar on the rear window (Figure 1)

2. Are any of these clips broken causing the rear window fabric to become loose?

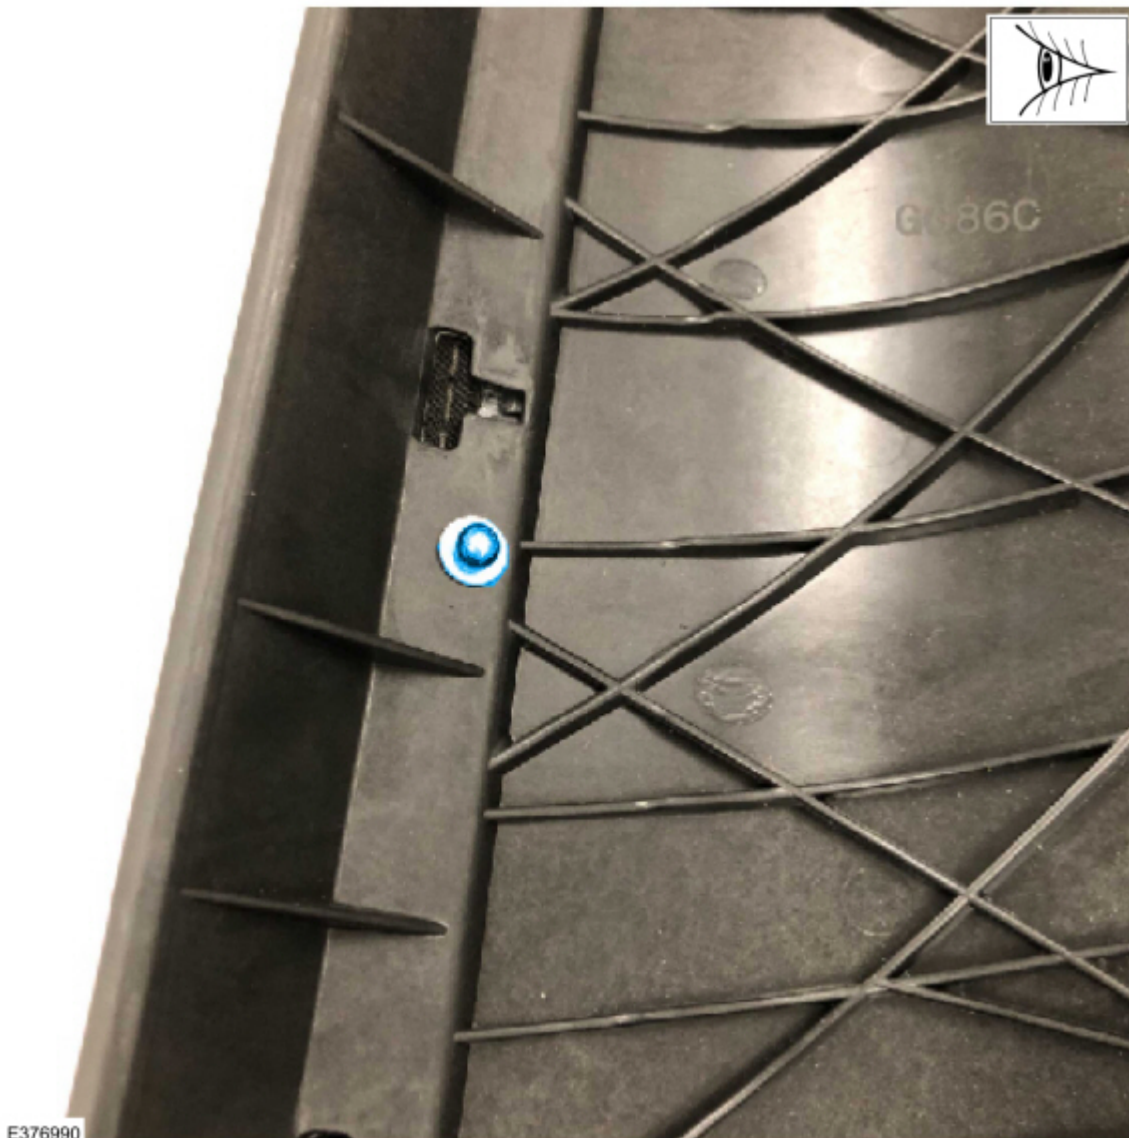
Figure 8

**NOTE:** The 5 mm gap between the D-pillar and the rear window plastic strip is critical. If this gap is too large or small, the rear window to rear quarter window fitment and appearance will be jeopardized.

**12.** Install all 5 rivets, one at a time, using one 5 mm flat washer as support around the back of each rivet. During this process, maintain the 5 mm gap as mentioned in Step 10. (Figure 8)
