ENGINES OM642 in all BlueTec diesel models

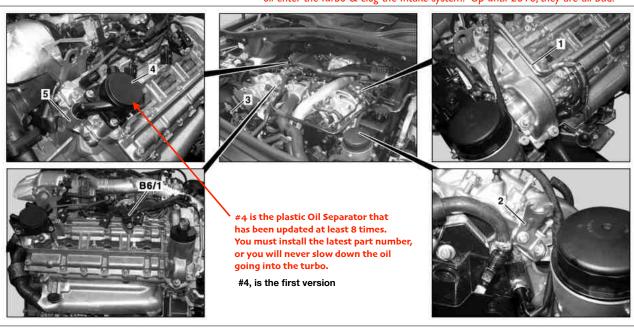
P01.20-2163-09

The Oil Separator should be one of the first things you replace. This lets to much oil enter the Turbo & clog the Intake system. Up until 2016, they are all bad.

- 6 Vent valve #6 is the second version metal Oil Separator
- 7 Pressure differential sensor bracket (DPF)

The second version metal Oil Separator was phased in to production around 2015. There were 2 versions of the metal oil separator. The Oil Separator should be the first thing you replace. Give your VIN number to your dealer & they can look up the latest one for your engine. The metal oil separator is not interchangeable with the plastic version. This is a good time to consider a Catch Tank. It will prevent any oil from entering the Turbo & intake system.

This is where you would attach the hose going to the Catch Tank. Disconnect the existing hose. You will plug the existing hose with a 14mm wooden dowel & clamp the hose to the dowel. There were two versions of the Oil Separator. This is the later metal version. You'll mount the Catch tank someplace on the passenger side fender or the fire wall. If you ever want to put everything back to the way it was, just remove the wooden blug from the hose and reattach it to the Oil Separator.

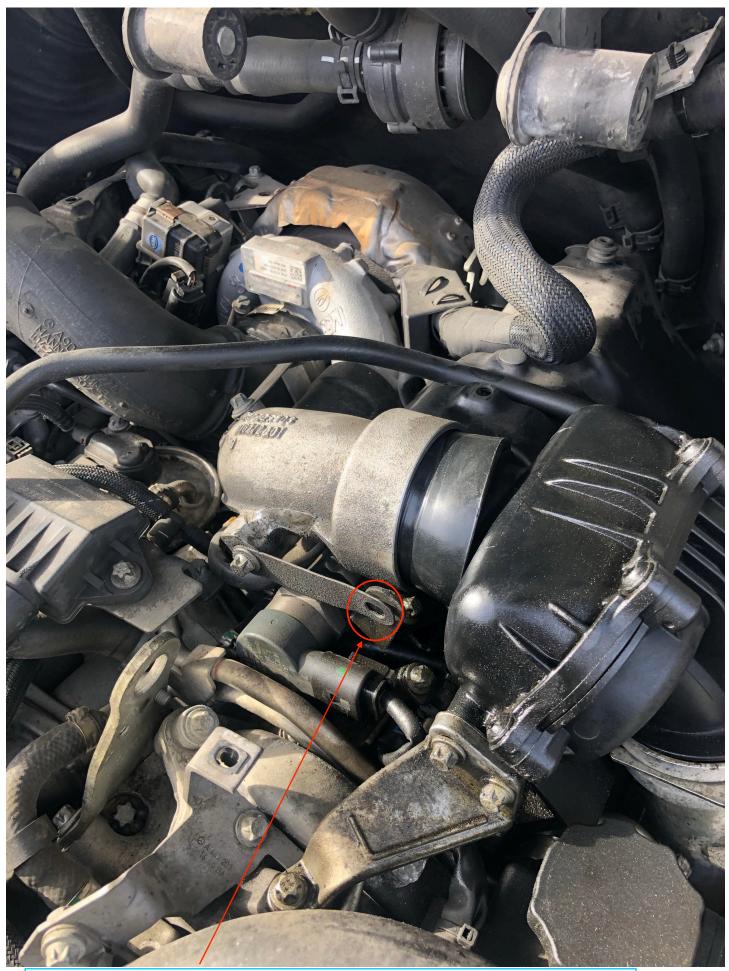
This missing bolt is common. It causes the air intake tubes to get loose and cause the engine to go into limp home.

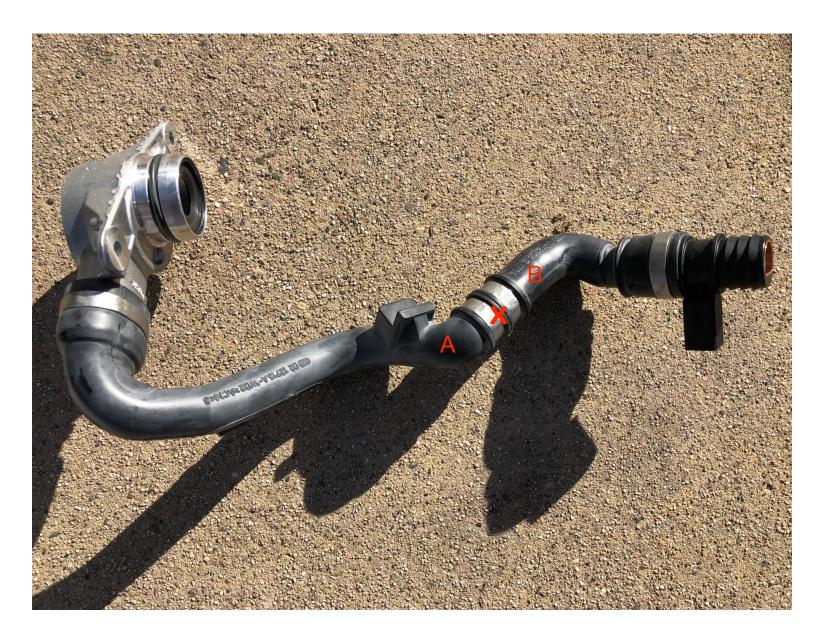
This is the newest metal style oil separator. It goes in all of the 2013 & newer BlueTec OM642 engines. Order by your VIN number. The parts department calls this a Vent Valve. MB will automatically update the order to the latest part number.

Mercedes didn't publish service bulletins about this, because it's an important part of the emission system. They don't want the EPA to know they keep updating this part, because they would have to recall every BlueTec they have made. Mercedes is trying to reduce the oil vapor that's going into the Turbo & then into the rest of the intake system. MB has updated this part more than 14 times. If your engine was built in 2018 or older, it needs this Oil Separator.

When you install a Catch Tank, you can cut the metal clamps at "X" and install the hoses to and from the Catch Tank here. Dirty air comes out of the hose marked "A" and clean air is returned into the hose marked "B".
