CERTAIN 2021-2024 MODEL YEAR BRONCO VEHICLES — REAR SHOCK ABSORBER EXTERNAL RESERVOIR CORROSION

SERVICE PROCEDURE

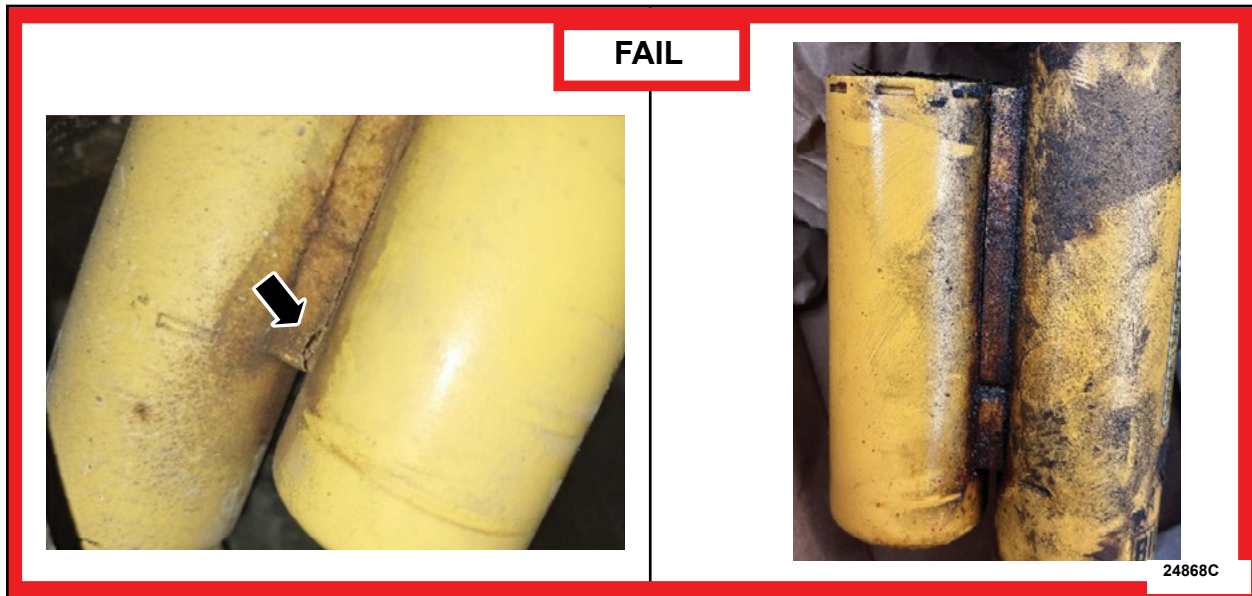
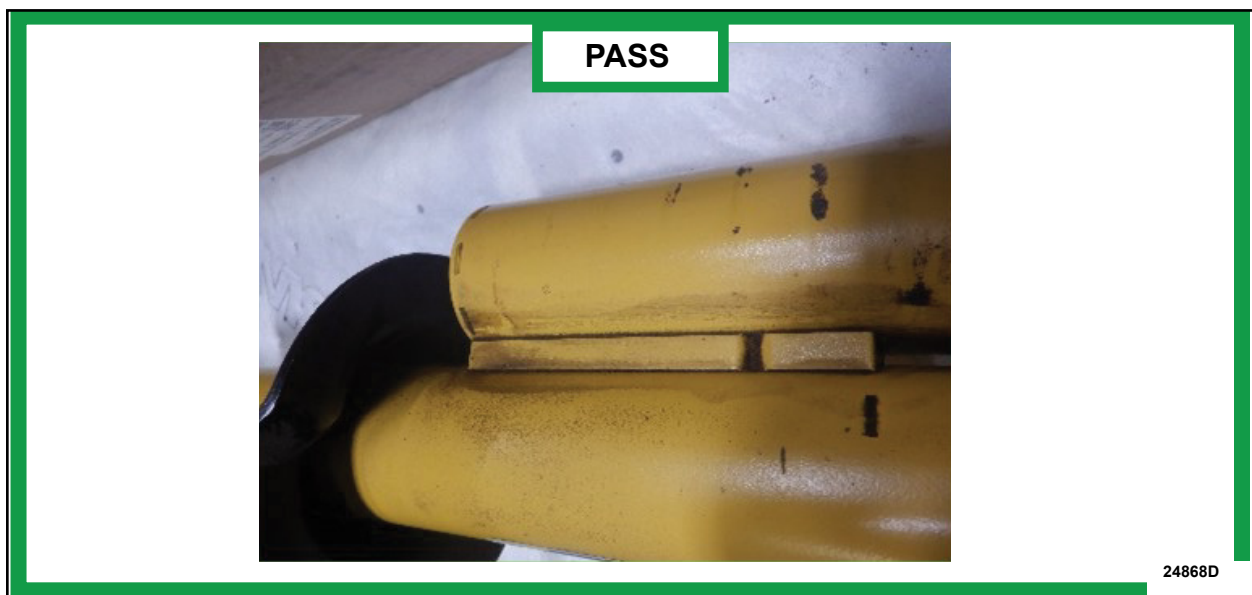
5. On both sides, inspect the rear shock and the shock to reservoir attachment flange areas for cracks, broken welds and/or leaks. See Figures 4 and 5.

- Were any cracks, broken welds and/or leaks found on either shock?

Yes - Submit photos of the failed rear shock(s) to the Special Service Support Center (SSSC), refer to the Photo Request Submission on Pages 8 and 9. Wait for the SSSC approval to begin any repairs. Then, replace both rear shock absorbers. Follow the WSM procedures in Section 204-04. This completes the FSA.

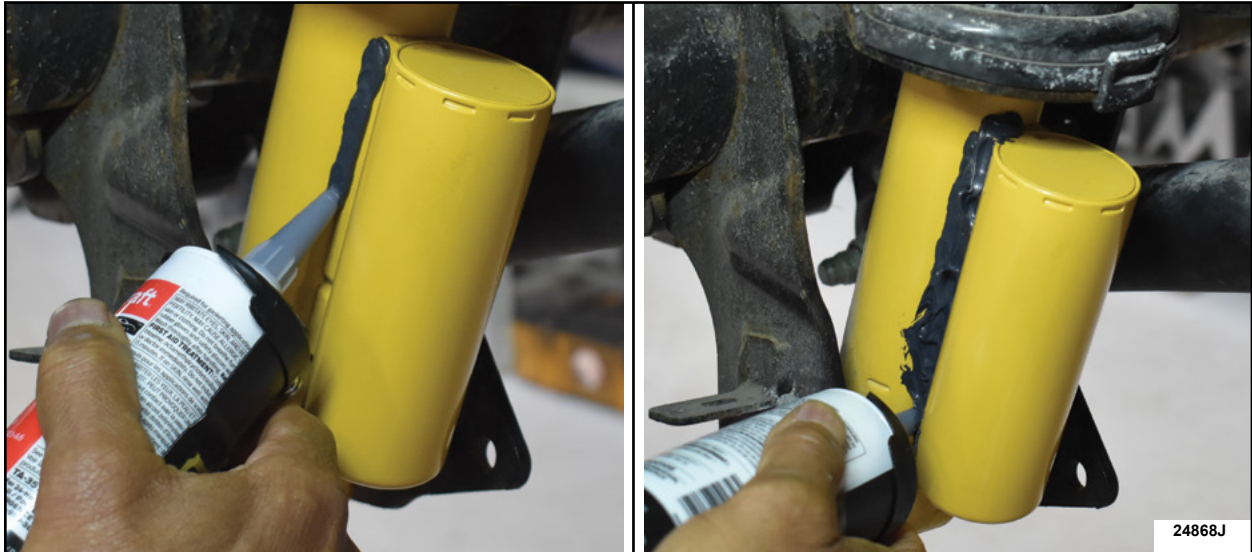
FIGURE 7

7. Using the provided Motorcraft® TA-357 High Performance Engine RTV Silicone, cut the sealant tube at a 45 degree angle for a quarter inch bead. Then, on both sides, apply a bead of sealant to the flange areas of the reservoir to shock body as shown in Figure 7. Continue applying the bead of sealant along both edges of the flange and until all flanges (top, bottom and both sides) around the reservoir are covered.

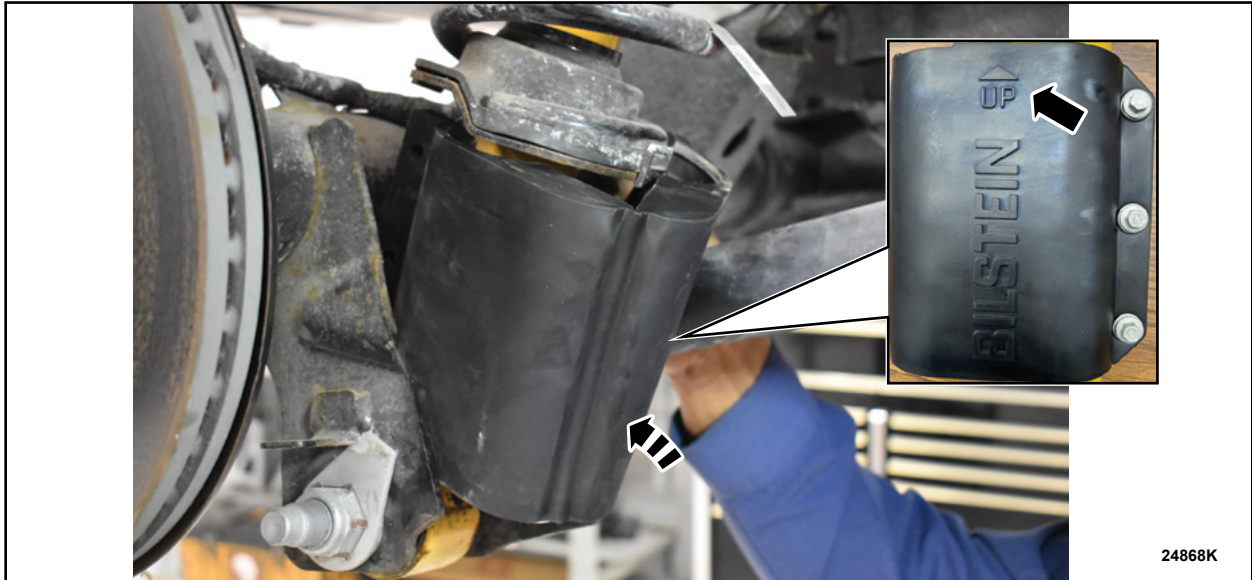
FIGURE 9

9. On both sides, position the *new* shock absorber reservoir retention clamp/shield around the shock and reservoir as shown in Figure 9. Make sure of the correct orientation by using the UP arrow on the shield and the attachment holes are facing the rear of the vehicle.

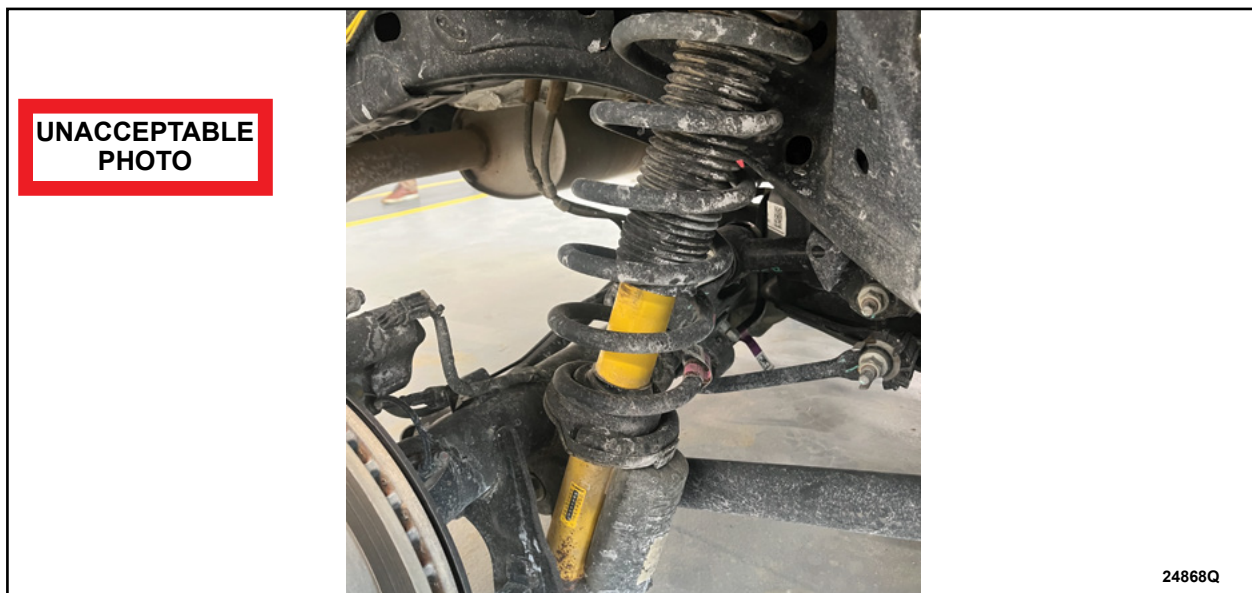
FIGURE 13

Unacceptable Photos: Is not clear or does not show the area of damage or failure.
